# WOOD DESTROYING PESTS AND ORGANISMS INSPECTION REPORT

Building No. 2731	Street TALISMAN DR	City Bakersfield	Zip 93304	Date of Inspection 1/13/2010	Number of Pages 4
----------------------	-----------------------	---------------------	--------------	---------------------------------	----------------------

## RCB Inspections and Termite Control

<b>GENERAL DESCRIPTION:</b> TWO STORY SINGLE FAMILY HOUSE VACANT	Inspection Tag Posted: CLOSET
	Other Tags Posted:

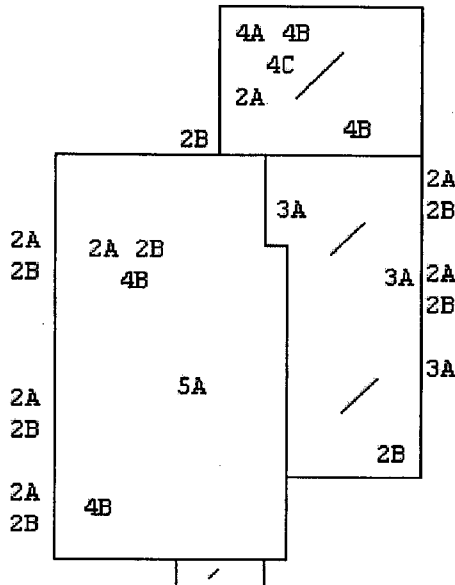
Diagram Not To Scale

2A - FINDING - Evidence of drywood termite infestation noted in areas marked on diagram.

2B - FINDING - Fungus and termite damaged wood noted at areas marked on diagram.

3A - FINDING - Fungus damaged wood noted as indicated on diagram.

4A - FINDING - Leak(s) noted in shower enclosure marked on diagram.

4B - FINDING - Water stains noted wall, ceiling and floor as indicated on diagram.

4C - FINDING - Leak noted at toilet seal as marked on diagram.

5A - FINDING - Inaccessible area marked on diagram.

RECOMMENDATION - Cover entire structure(s) and fumigate for the elimination of drywood termites. Cover or remove accessible termite pellets.

RECOMMENDATION - Repair fungus and termite damage at wood siding, support post, roof eaves, deck and wood floor. Painting is not included in this estimate.

RECOMMENDATION - Replace fungus damaged wood eaves at area marked on diagram. Owner to contact licensed roofing company to repair roof surfaces at areas of wood replacement. (\_\_\_\_\_) Customers initials

RECOMMENDATION - Owner to have area(s) at shower inspected by a qualified tradesman and repair or replace as may be deemed necessary.

RECOMMENDATION - Periodically inspect area.

RECOMMENDATION - Owner to contact a licensed tradesman to make necessary repairs.

RECOMMENDATION - If inspection of area(s) at sub area is required it must be made accessible. We will then re-inspect and issue a supplemental report of our new findings. RCB recommends further inspection of this area. FURTHER INSPECTION IF REQUIRED
