### WOOD DESTROYING PESTS AND ORGANISMS INSPECTION REPORT

Building No. 609	Street FRANCIS ST	City Bakersfield	Zip 93308	Date of Inspection 2/12/2009	Number of Pages 4
---------------------	----------------------	---------------------	--------------	---------------------------------	----------------------

GENERAL DESCRIPTION: ONE STORY, SINGLE FAMILY HOUSE. UNFURNISHED AND UNOCCUPIED.	Inspection Tag Posted: GARAGE
	Other Tags Posted:

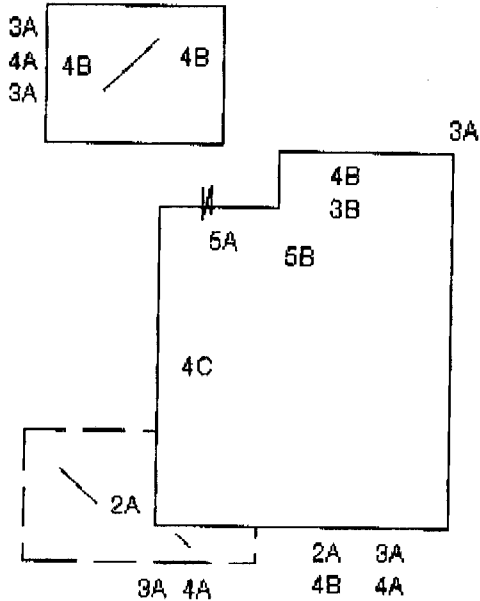
Diagram Not To Scale

2A - FINDING - Evidence of drywood termites noted in areas marked on diagram.

3A FINDING - Fungus damaged wood noted roof eaves as indicated on diagram.

3B - FINDING - Water stains and/or damage noted in area(s) marked on diagram.

4A - FINDING - water stains noted roof eaves as indicated on diagram.

4B - FINDING - Exterior stucco of structure is badly weathered which makes it susceptible to excessive moisture and fungus infection as indicated on diagram.

4C - FINDING - Water stains noted wall, ceiling and sheathing as indicated on diagram.

5A - FINDING - The subarea is inaccessible for inspection due to standing water as marked on diagram.

SB - FINDING - Stall shower pan marked on diagram was not water tested because water had been turned off.

RECOMMENDATION - Cover entire structure(s) and fumigate for the elimination of drywood termites. Cover or remove accessible termite pellets. \*Note\*: When a property is fumigated, our crew must walk on the roof surfaces and perimeter areas of the building in order to put the tarp in place, and damage may occur to certain types of roofs, roof eaves, roof ridges and/or roof corners. Neither RCB nor its licensed fumigator will assume any liability for such damage or consequential damage that may occur to roofs or roof coverings and areas below roofs.

RECOMMENDATION - Cut out fungus damage and repair roof eaves.  
SECTION 1

RECOMMENDATION - Remove and replace fungus damaged wood in floor. Owner to have floor covering replaced after repairs are completed.  
SECTION 1

RECOMMENDATION - Owner to have area(s) at roof covering inspected by a qualified tradesman and repair or replace as may be deemed necessary.  
SECTION 2

RECOMMENDATION - Owner to have area(s) at stucco inspected by a qualified tradesman and repair or replace as may be deemed necessary.  
SECTION 2

RECOMMENDATION - Periodically inspect area.  
SECTION 2

RECOMMENDATION - If inspection of area(s) at sub area is required it must be made accessible. We will then re-inspect and issue a supplemental report of our new findings. RCB recommends further inspection of this area. FURTHER INSPECTION IF REQUIRED

RECOMMENDATION - Water is to be turned on for testing shower pan. We will re-inspect and issue a supplemental report of our new findings. FURTHER INSPECTION IF REQUIRED
