# WOOD DESTROYING PESTS AND ORGANISMS INSPECTION REPORT

Building No. 21	Street DUNLAP ST	City Bakersfield	Zip 93309	Date of Inspection 10/22/2009	Number of Pages 4
<b>RCB Inspections and Termite Control</b> <b>3400 Panama Ln. Suite F #194</b> <b>Bakersfield CA 93313</b> <b>Tel 661-398-2151 Fax 661-836-2645</b> <b>termitehawk@sbcglobal.net</b>				Report # : 12060 Registration # : 4980 Escrow # :	
Ordered by: MIKE GRIGG ELITE AUCTION 1700 CHERRY ST BAKERSFIELD CA 93304		Property Owner and/or Party of Interest: 21 DUNLAP ST Bakersfield CA 93309		Report sent to: MIKE GRIGG ELITE AUCTION 1700 CHERRY ST BAKERSFIELD CA 93304	
COMPLETE REPORT <input checked="" type="checkbox"/> LIMITED REPORT <input type="checkbox"/> SUPPLEMENTAL REPORT <input type="checkbox"/> REINSPECTION REPORT <input type="checkbox"/>					
GENERAL DESCRIPTION: ONE STORY SINGLE FAMILY HOUSE VACANT				Inspection Tag Posted: GARAGE	
Other Tags Posted:					
An inspection has been made of the structure(s) shown on the diagram in accordance with the Structural Pest Control Act. Detached porches, detached steps, detached decks and any other structures not on the diagram were not inspected.

Page 2 of inspection report

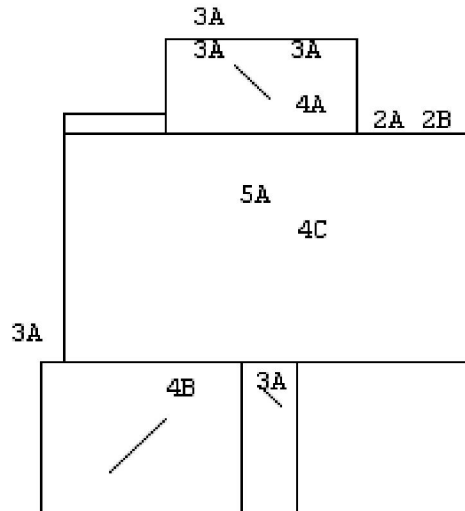
**Diagram Not To Scale**

2A - FINDING - Evidence of drywood termite infestation noted in areas marked on diagram.

2B - FINDING - Fungus and termite damaged wood noted at areas marked on diagram.

3A - FINDING - Water stains and/or damage noted in area(s) marked on diagram.

4A - FINDING - Plumbing leak noted at area marked on diagram.

4B - FINDING - Leak noted at water heater as marked on diagram.

4C - FINDING - Water stains noted wall and ceiling as indicated on diagram.

5A - FINDING - Inaccessible area marked on diagram.

RECOMMENDATION - Cover entire structure(s) and fumigate for the elimination of drywood termites. Cover or remove accessible termite pellets.

RECOMMENDATION - Repair fungus and termite damage at support post. RCB will prime replaced wood. Painting is not included in this estimate.

RECOMMENDATION - Repair water damage area at wood siding, rafter, fascia and threshold.

RECOMENDATION - Repair leaks at exterior plumbing.

RECOMMENDATION - Owner to have area(s) at water heater inspected by a qualified tradesman and repair or replace as may be deemed necessary.

RECOMMENDATION - Periodically inspect area.

RECOMMENDATION - If inspection of area(s) at is required it must be made accessible. We will then re-inspect and issue a supplemental report of our new findings. RCB recommends further inspection of this area.  
FURTHER INSPECTION IF REQUIRED
